Loma Prieta Earthquake October 17, 1989

PRELIMINARY
RECONNAISSANCE REPORT

This report was sponsored by
the Earthquake Engineering Research Institute
and the Committee on Natural Disasters
of the National Research Council's
Commission on Engineering and Technical Systems,
with support from
the National Science Foundation
November 1989

Earthquake Engineering
Research Institute
89-03

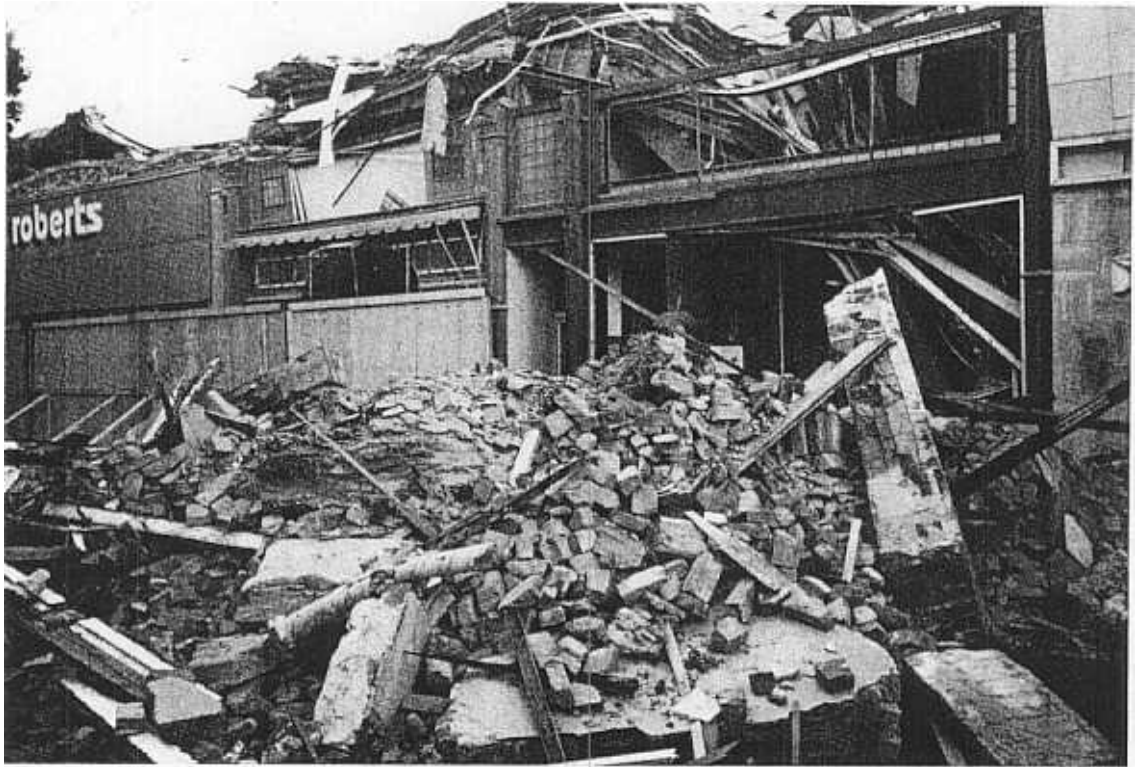
Figure 1.1 The Pacific Garden Mall in Santa Cruz. Many merchants in older downtown areas throughout the affected region may have difficulty recovering because the earthquake took place so close to the important holiday shopping period.

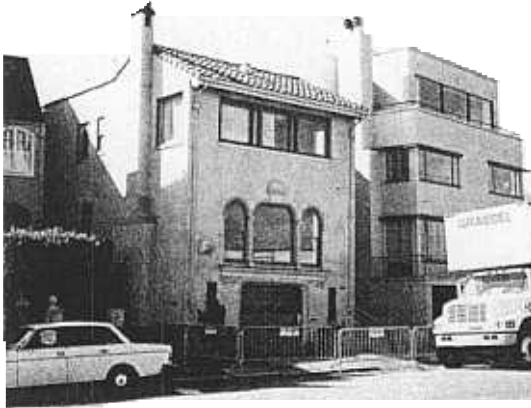
Figure 3.3 Settlement and tilting of buildings in the Marina District of San Francisco

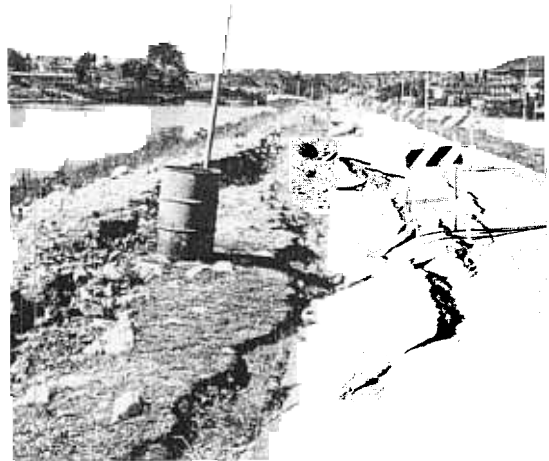
Figure 3.4 Lateral spreading and slumping of the levee along the San Lorenzo River in Santa Cruz

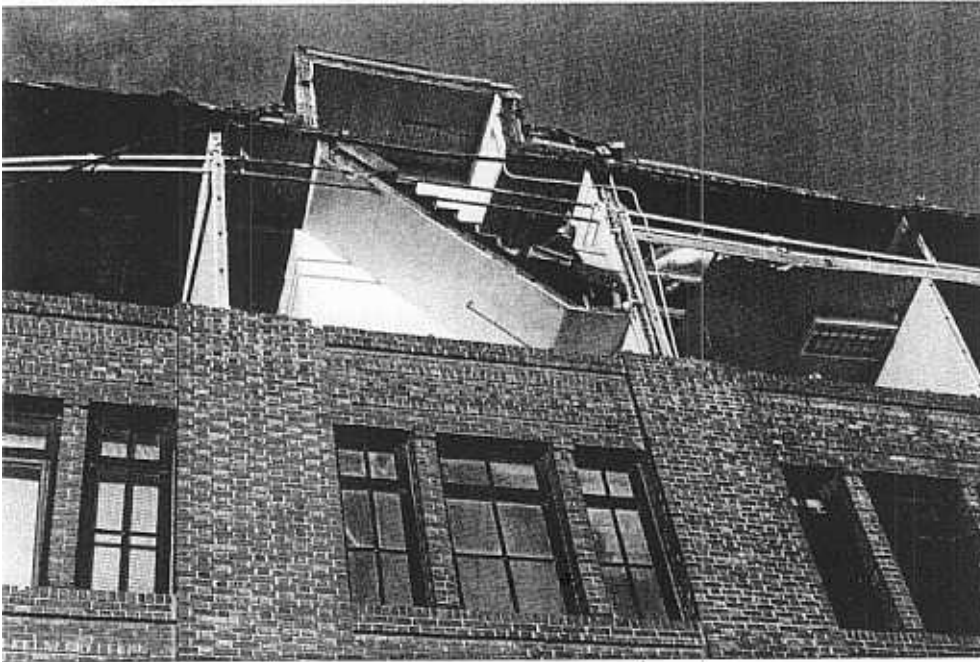
Figure 4.1 Unreinforced masonry building on 6th Street in the South of Market District of San Francisco that suffered major damage during the earthquake

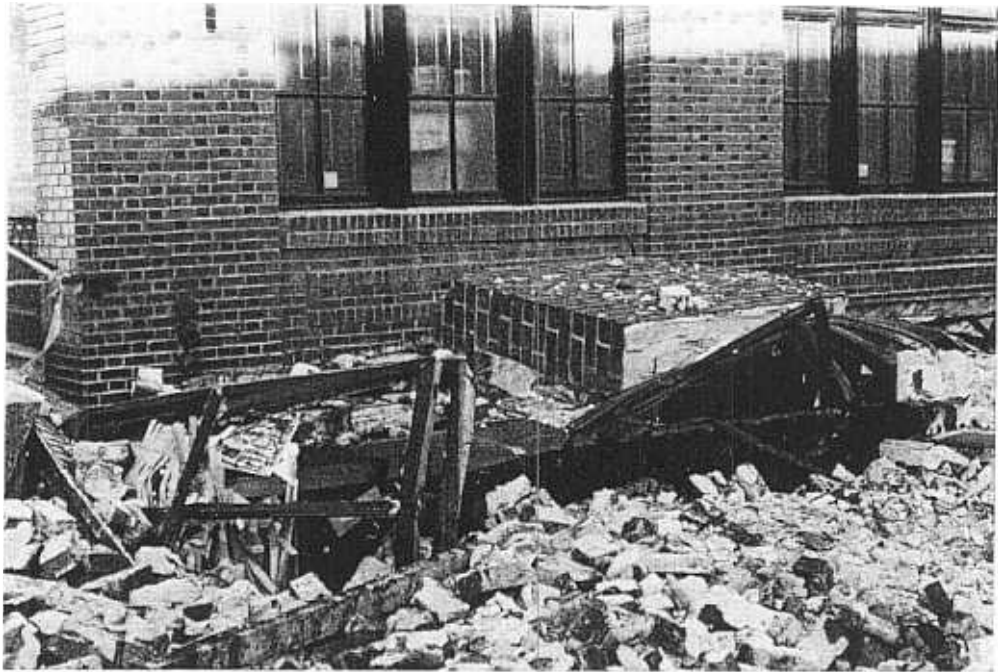
Figure 4.2 A portion of the unreinforced masonry wall that fell from a building on 6th Street in the South of Market District of San Francisco

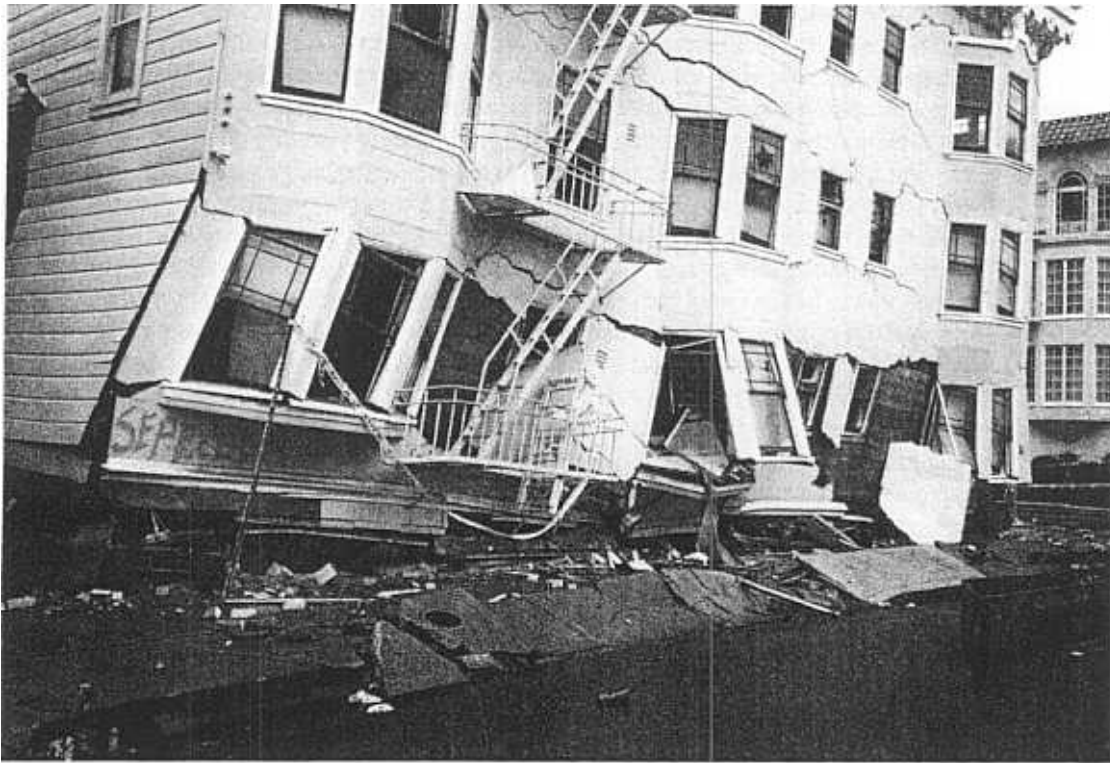
Figure 4.3 Buildings that failed in the San Francisco Marina District typically had structural vulnerabilities and were also built on soft-soil deposits.

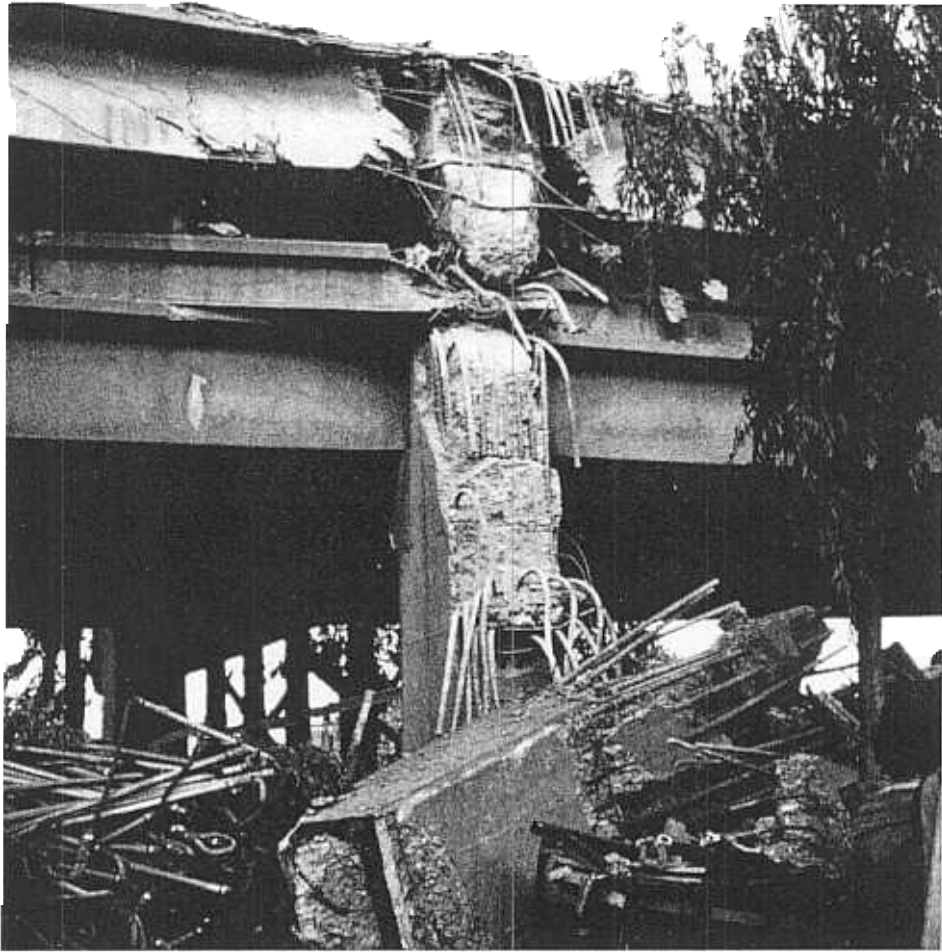
- The greatest damage occurred to older structures on poor ground. The Cypress Street Viaduct and the Bay Bridge are examples of this.
- Bridges of a design and form similar to the Cypress Street Viaduct would very likely have been very severely damaged if the shaking had been of longer duration. In San Francisco, severe damage has been sustained by the Embarcadero structure near Market Street, the I-280 elevated freeway near China Basin, and portions of Highway 101 near Gough and Franklin streets.

Figure 5.1 The greatest damage from the earthquake occurred to older structures on poor ground, such as the I-880 Cypress Street Viaduct.

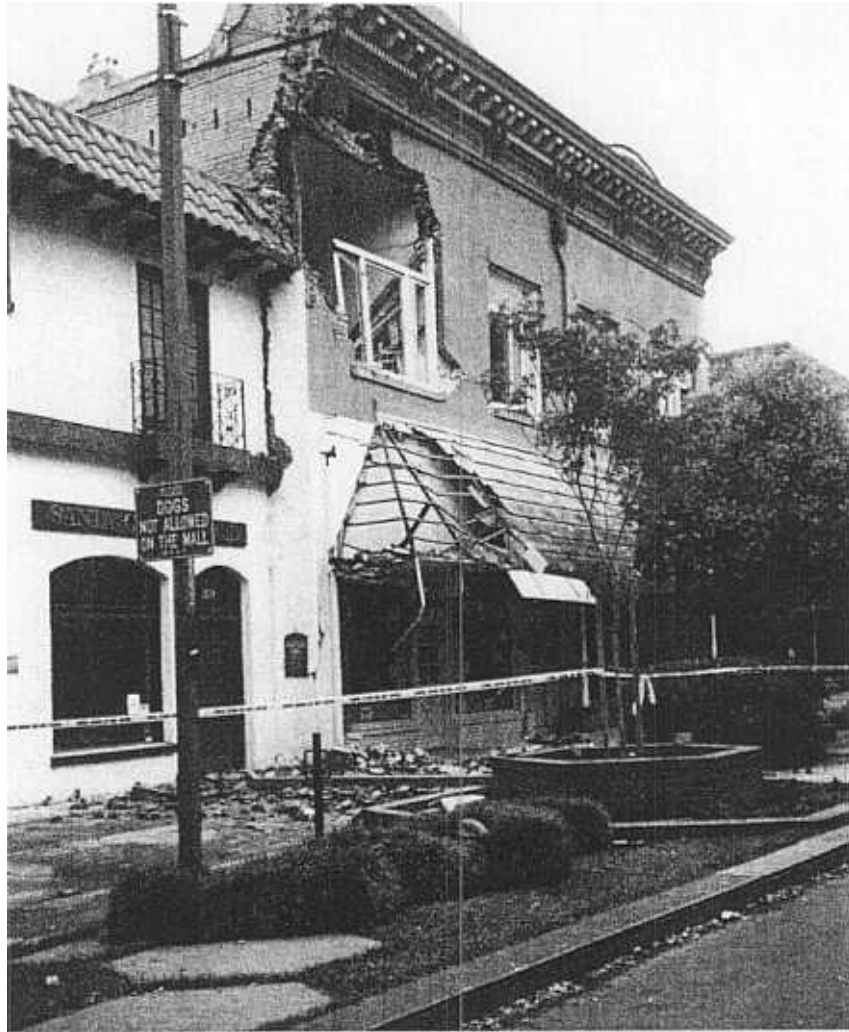
Severe damage to rehabilitated unreinforced masonry buildings in Los Gatos, Watsonville, and Santa Cruz emphasizes the danger of architectural and interior rehabilitation that does not include seismic strengthening. In Santa Cruz, particularly, many structures on Pacific Garden Mall had been attractively and expensively rehabilitated without appreciable strengthening (see Figure 6.1). Approximately 20 buildings will be demolished, and total losses in Santa Cruz are approaching \$170 million.

Figure 6.1 Although many of the structures on the Pacific Garden Mall in Santa Cruz were attractively and expensively rehabilitated, the improvements did not include appreciable strengthening and many were lost.

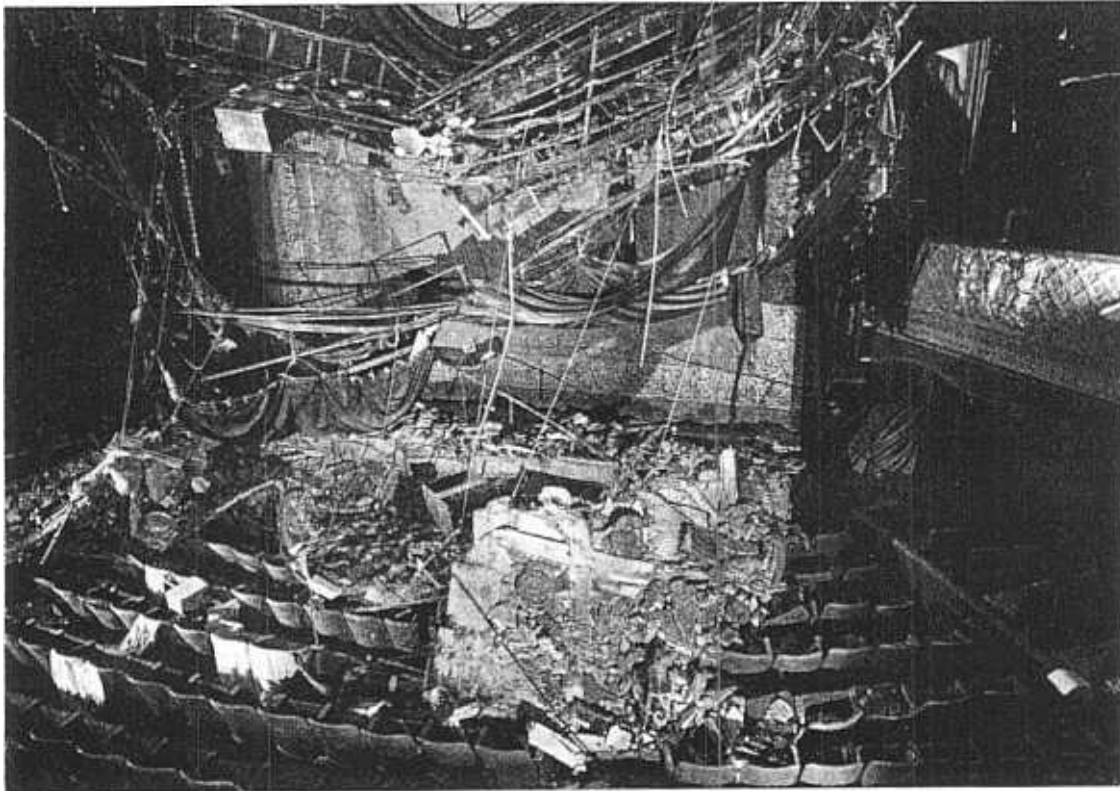
Figure 6.2 The Geary Theater in San Francisco (Courtesy Frederic Larson/San Francisco Chronicle)

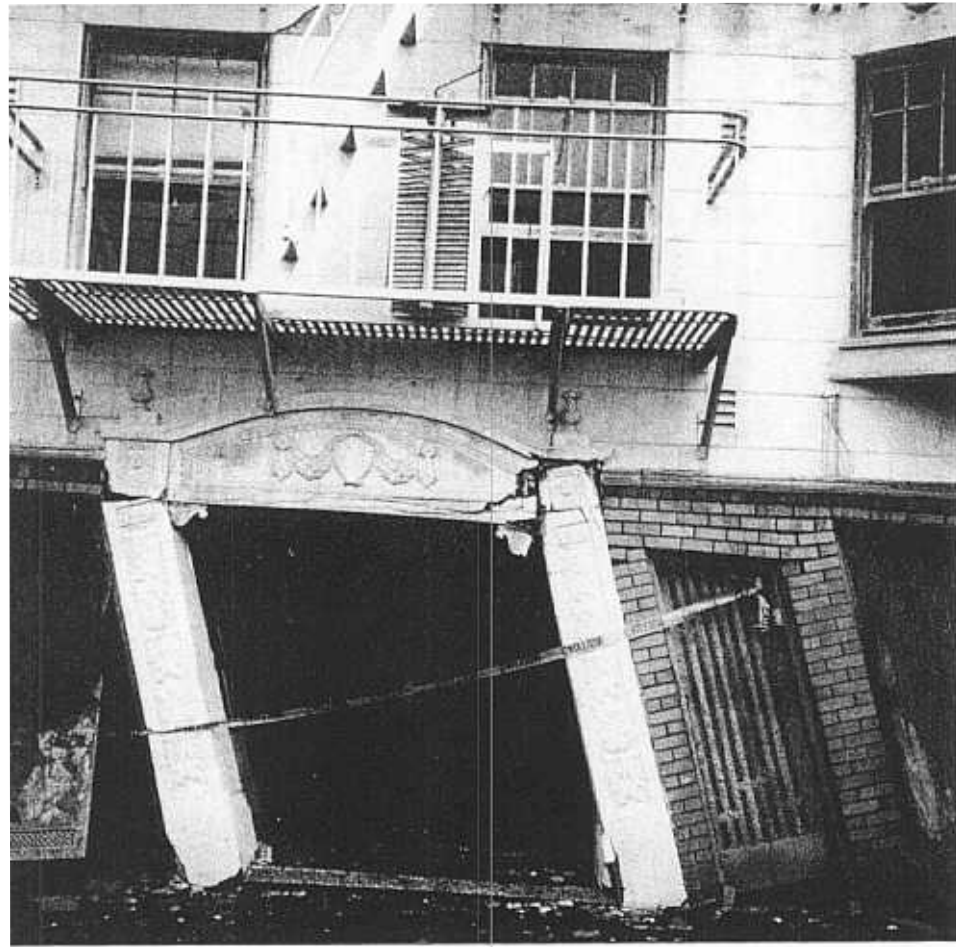
Figure 6.3 Characteristic “soft story” vertical-configuration effect on building performance in the Marina District
